Title		
<b>1920s Condenser Microphone</b>		
Size	Number	Revision
A4		<b>1.1</b>
Date:	14-Sep-2006	Sheet 1 of 1
File:	D:\CLIENTS\VAUGHAN~1\1920SMIC.SCH Drawn By: I. DuRIEU

# 1920s Condensor Microphone

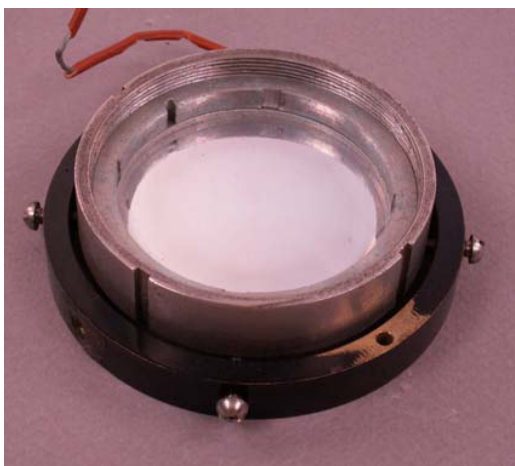
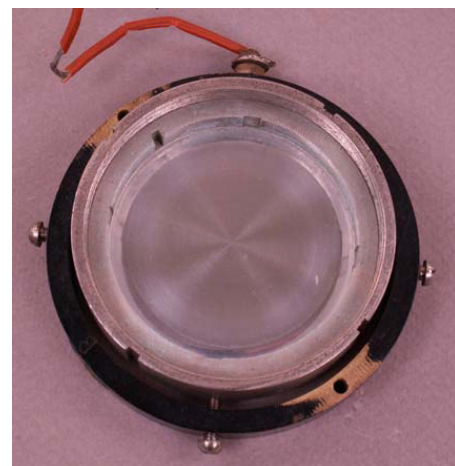
Looking at the rear of the diaphragm after the back plate assembly had been removed.

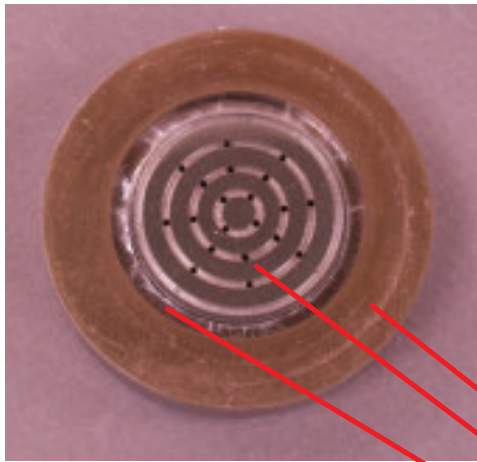
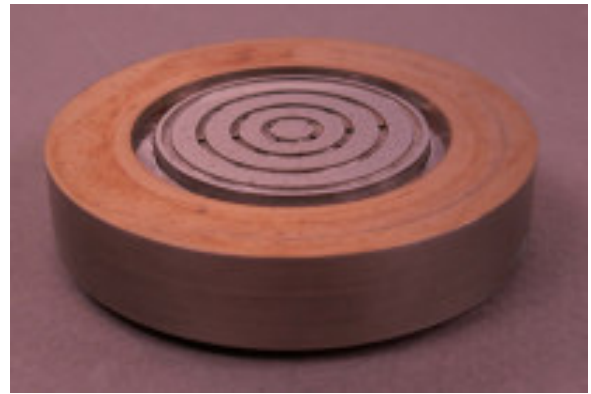
Back plate assembly.  
Outer brass ring is grounded.  
32mm back plate...  
is insulated from the outer ring with mica.

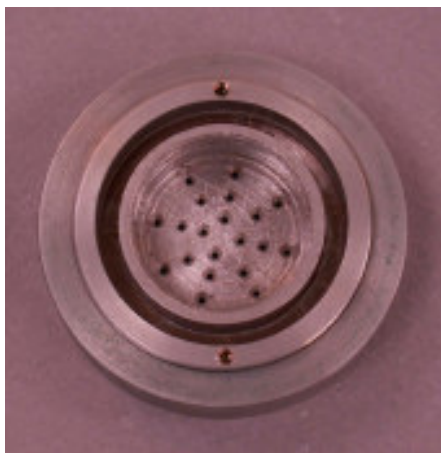
Rear view of above assembly.

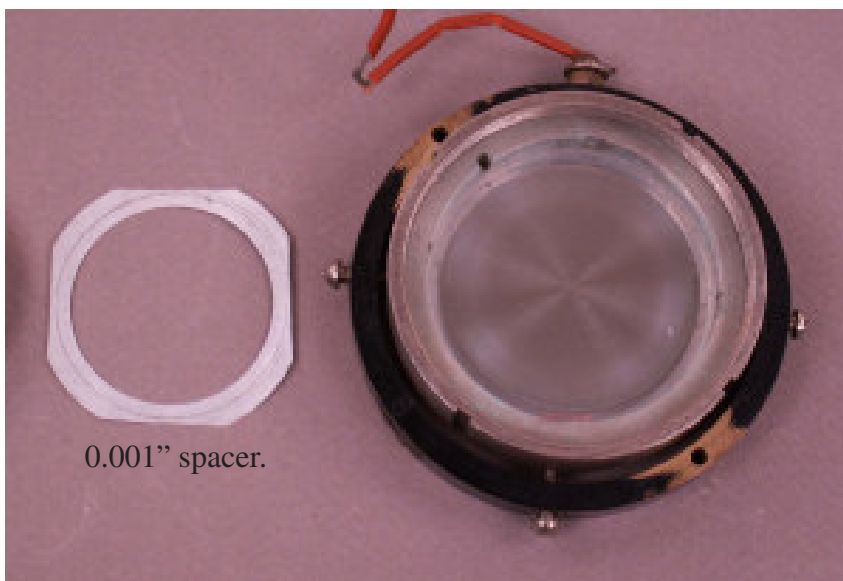
0.001" spacer.

Back plate assembly is spaced away from the diaphragm by a 0.001" thick spacer.

Once clamped together, the diaphragm would short out to the back plate. The mica supporting the back plate was slightly distorted. Rather than risk damaging the mica insulation, it was decided to leave it as is. An additional spacer was fitted. This reduced the capacitance from 120pF to 84pF. An unfortunate byproduct of getting it to work at all.

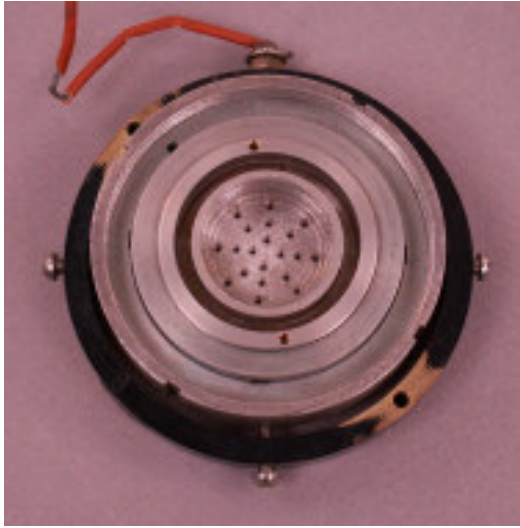
Back plate assembly drops into main body.

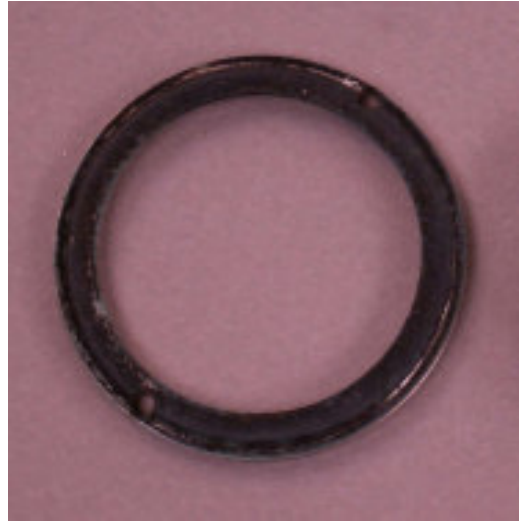
Back plate assembly clamping ring is threaded on its outer edge.

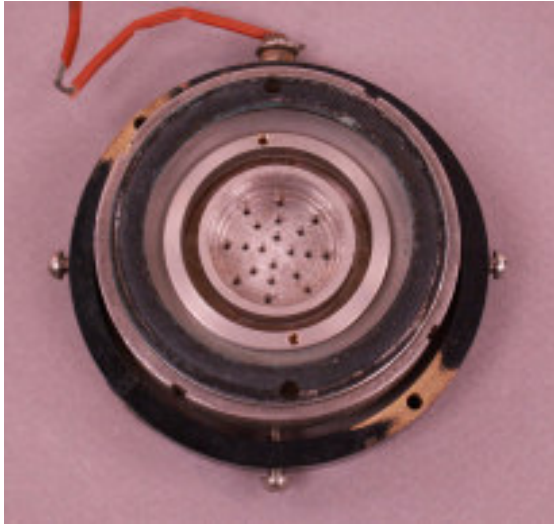
Back plate assembly clamped into place.

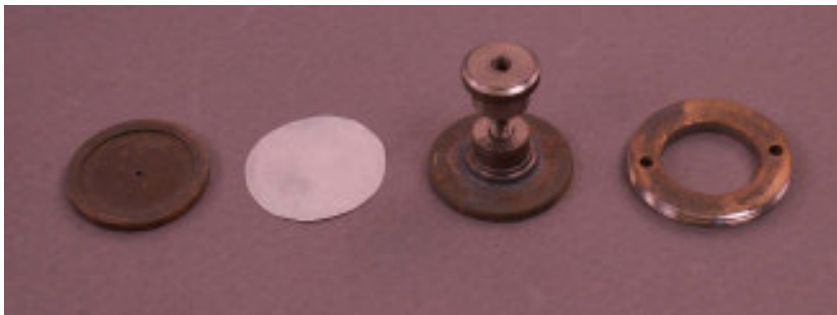
Nearest Diaphragm

Components on rear of the back plate.  
A 0.001" thick disk is sandwiched into a small cavity between two brass disks, one of which has the terminal attached.

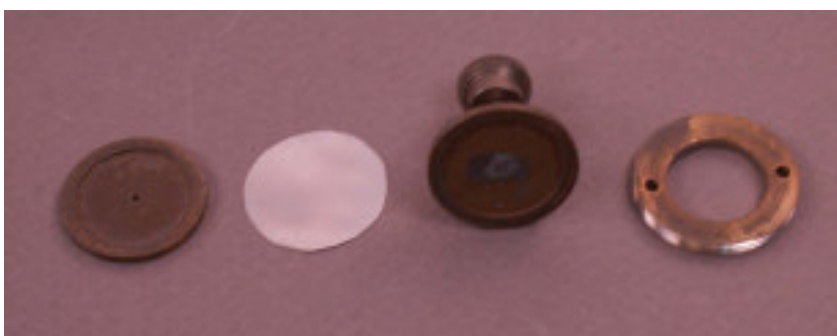
Assembly of components into cavity on rear of the back plate
